# River Restoration NEWS

Issue 34  
December 2009

Newsletter of the RIVER RESTORATION CENTRE

## RRC's Houting Outing to Western Denmark

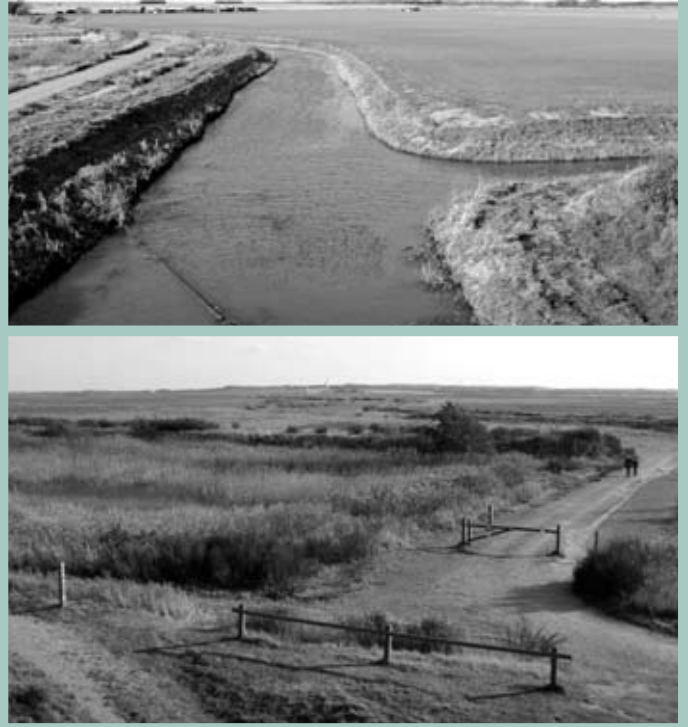
### **Figure 1:**

*The straightened river system alongside drained and agricultural land depicts the old Skjern landscape (top), while the array of developing wetland habitats shows the return of its former mosaic floodplain (bottom).*

Skjern project originally aimed to restore watercourses that were straightened for intensive farming in the 1960s, and historical mapping from 1871 was used to inform the restoration of river meanders and 2220 hectares of surrounding wetland habitat (*Figure 1*). During the works a total of 2.7 million cubic metres of soil was removed, enough to fill a series of dumper trucks from the Skjern to Rome, and the length of the Skjern was increased by four kilometres. Straightened sections that were not infilled have been retained as linear ponds.

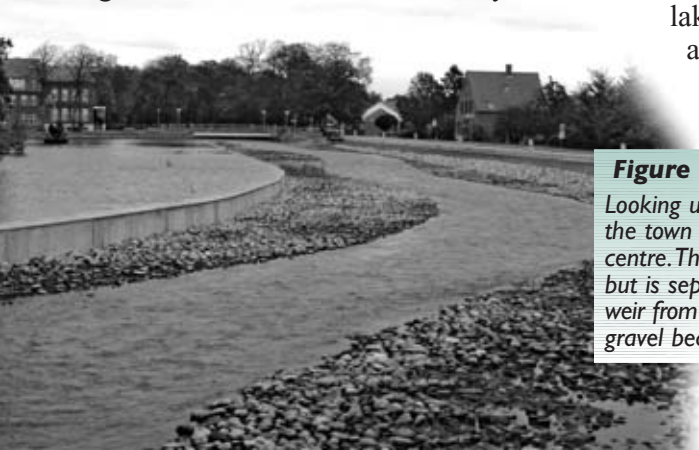
### **Figure 2:**

*Looking upstream from the old Mill in the town of Tonder towards the town centre. The mill pond level is retained, but is separated by a lateral overspill weir from the new 'free-flowing' river with gravel bed and banks. October 2009*

The aim of a £1.1 million project in the town of Tonder on the River Vida is to restore houting passage, retain parts of an old millpond as a nursery area, and create spawning grounds. While the mill wheel was no longer present at the start of the project, a two metre high weir created a physical obstruction to houting migration. The pond and the river have now been separated with the creation of a lateral sheet-piled, concrete-faced, broad-crested weir. Gravel bed and banks have been installed (*see Figure 2*) and an otter pass has been built under the bridge just downstream of the reach shown. Two sluice gates and a fish ladder upstream of the mill bridge have been removed and downstream Tonder rowing club also have a new access point to the river to minimise disturbance. Flood banks on the northern side have been set back to ensure flood risk doesn't increase and eighty hectares of shallow-water lakes will form new nursery areas for houting fry. From Tonder, the watercourse

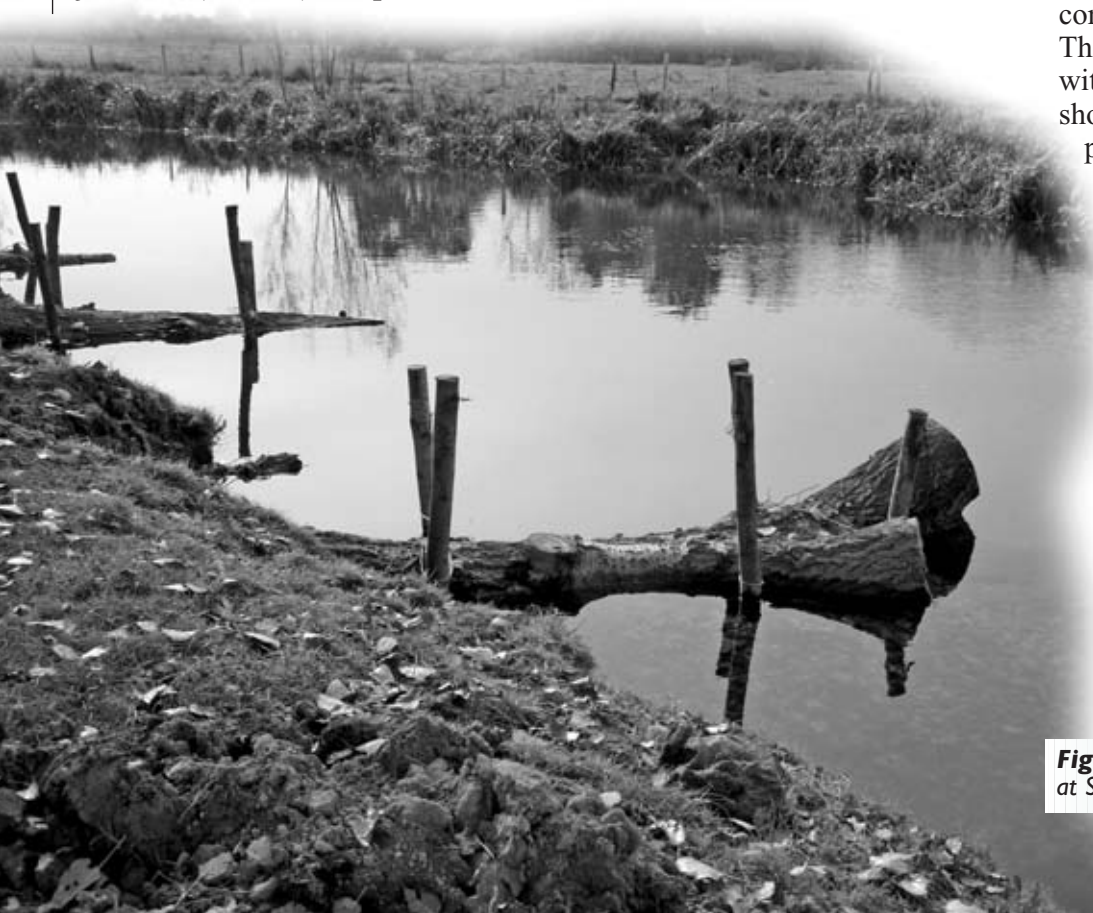
**Figure 1.** Wood deflectors installed at Seven Hatches

restoration works assessments, so this took between 2 and 4 years to complete for each site. The projects were divided into discreet reaches each of which was assessed separately. Repeat photography was also carried out at all of the assessment stages (*see Figures 1 and 2*).

vegetated, further reducing the channel width. Throughout the project an adaptive management process was adopted so that the lessons learnt from one site could be applied to the next. In terms of the deflectors, one lesson taken forward into later works was to increase the size of the trees used. The RRA process highlighted that changes to the hatch operation (for example the hatches being raised permanently), where it occurred, had the biggest immediate impact in the short term by reducing water depth and increasing velocities with the resultant removal of silt from the gravel substrate.

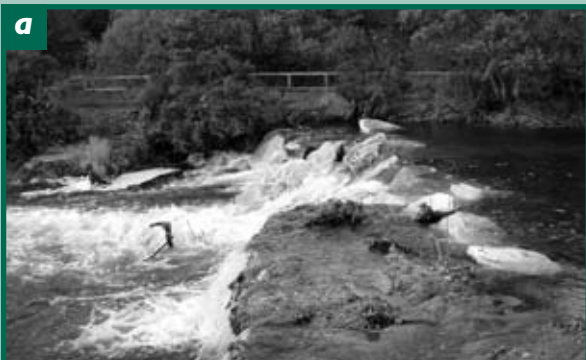
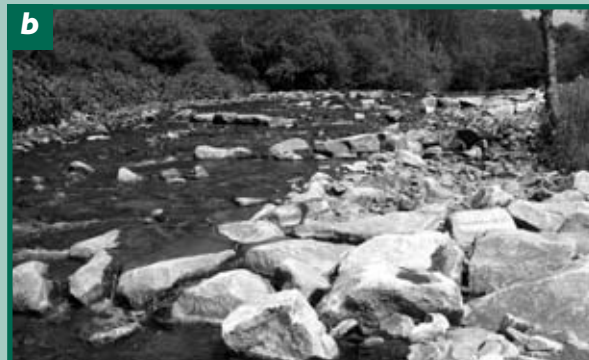
**Figure 1:** River Neb with (a) dilapidated weir (summer 2006), and (b) the rock ramp (spring 2007) which has replaced it

ensure passability only when weirs need to be replaced. A particularly good example was the installation in 2006 of a rock ramp to replace a dilapidated weir on the River Neb, which had for many years delayed upstream passage of salmon and sea trout, leaving them vulnerable to poachers (*see Figure 1*). The ramp incorporates a low-flow channel, thereby also aiding dispersion of resident brown trout. Although there is not enough monitoring data available to draw robust conclusions, surveys conducted in 2005 and 2007 revealed similar numbers of brown trout but a quadrupling of 0+ salmon at a few kilometres above the site. The ramp also resulted in considerable financial savings for the DoT when compared to a like-for-like replacement.

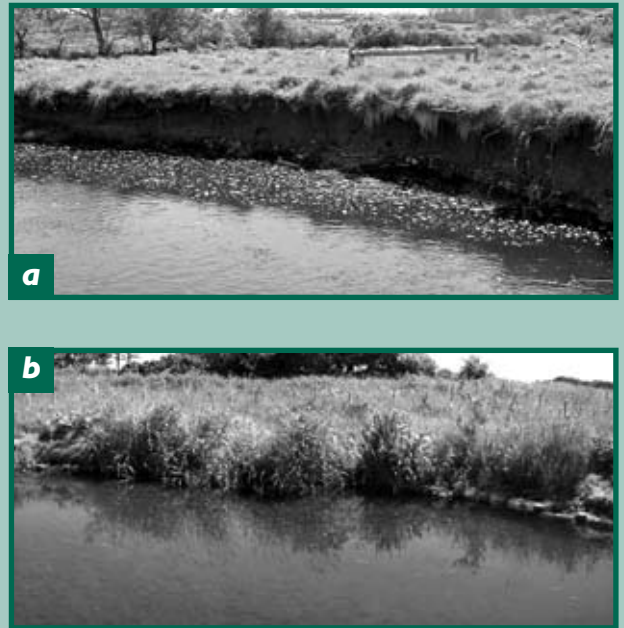
**Figure 2:**  
Bend on the Silver Burn in  
(a) August 2006, showing  
cantilever erosion,  
and (b) June 2009, three  
years after 'green'  
engineering

Until fairly recently, most bank revetments conducted by the DoT had employed traditional hard engineering solutions such as gabion baskets and 'stob and mesh' (post and wire-mesh barriers back-filled with stone). However, since 2006, greener solutions have been employed wherever possible. The first major example was the revetting of a bend prone to severe cantilever erosion above a large but passable weir on the Silver Burn (*see Figure 2*). 'Stob and mesh' techniques had

failed in the past leaving potential for the river to divert from the weir, an undesirable prospect in this instance. The work was used as a training exercise in soft engineering for the DoT's works gangs with Salix River & Wetland Services Ltd contracted to supply the design and supervision. Faggots topped with coir roll were used to construct the desired course and, after regrading and seeding, the bank was reinforced with NAG350 geotextile. In order that only plants of native Manx provenance were used, the coir roll was installed bare and later planted with marginals. A small backwater was also created at the site and a copse of native trees planted to further enhance the area's wildlife potential. The project has led to other green initiatives such as the creation of a lagoon for supplying pre-planted coir roll and the sourcing of faggots from the Manx Wildlife Trust using willow cut during coppice management of nature reserves.
